# PROJECT PROFILE

## MIT N4-Bldg. Albany Street Parking Garage - Cambridge, MA

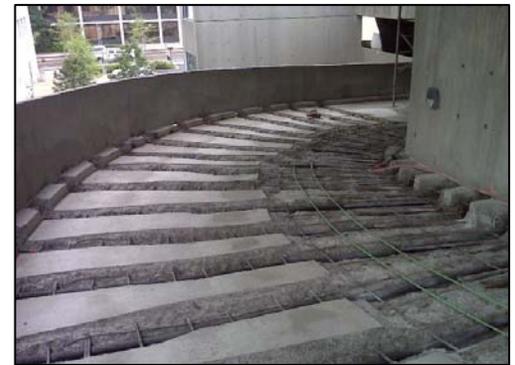
**Semicircular Ramp Finish Demo**

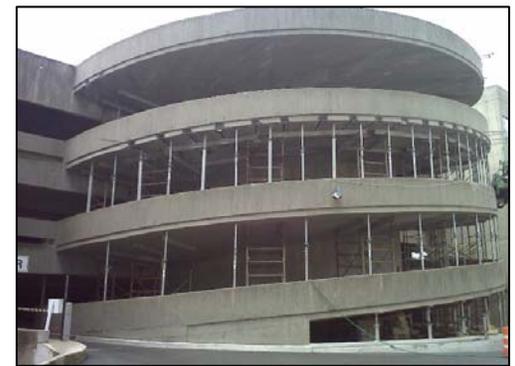
During Phase 1 work on the semicircular ramp, as the cleanup crew made their way down a large demolished area on the third level, they noticed that the bonded post-tension cables were deteriorated to the point of failure. These PT cables ran perpendicular to the direction of the ramp and amounted to approximately two-thirds of all the PT cables on this level. The work was immediately stopped, the owner and engineer were called and it was determined that 18 emergency shoring towers were immediately required to shore the third level ramp down to grade level.

**Semicircular Ramp with emergency shoring**

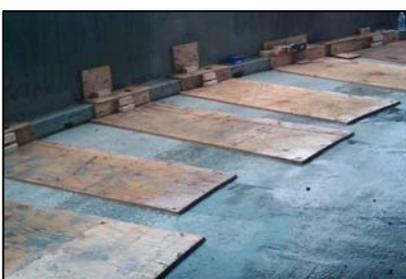
**Semicircular Ramp  
Topside Formwork**

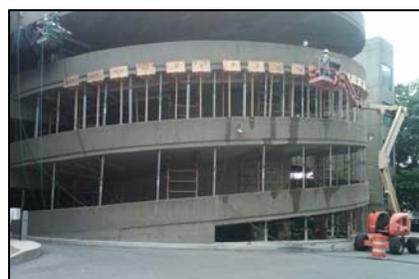
**Semicircular Ramp  
PT Formwork**

Given the short summer timeframe in which to complete the project, the most challenging aspect was completing the PT replacement work, grouting the PT ducts, pouring the concrete to embed the PT ducts, curing the concrete, and applying the urethane coating to the semicircular ramps. Considering the concrete curing and time for repair, the schedule was extremely tight when including the coating application.

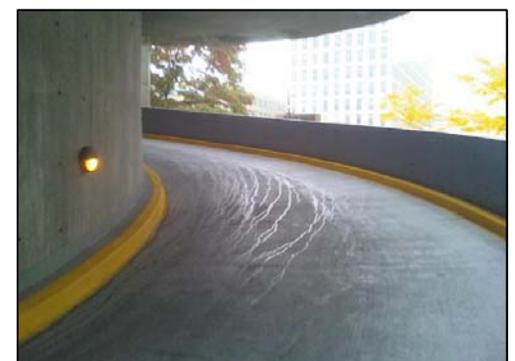
**Completed  
Semicircular Ramp Surface**
