PROJECT PROFILE

Cleveland Terrace - Washington, DC

Restoration of two-level parking deck below residential condos

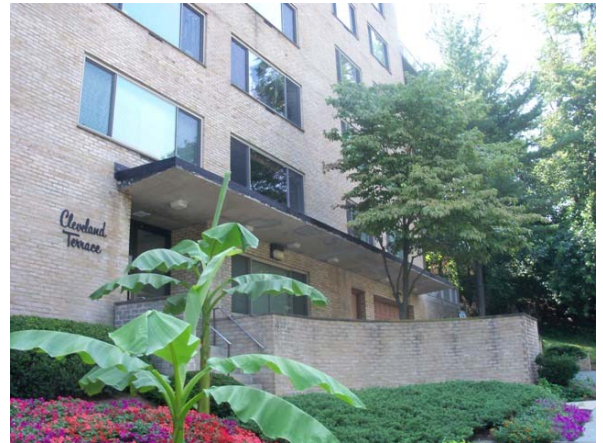
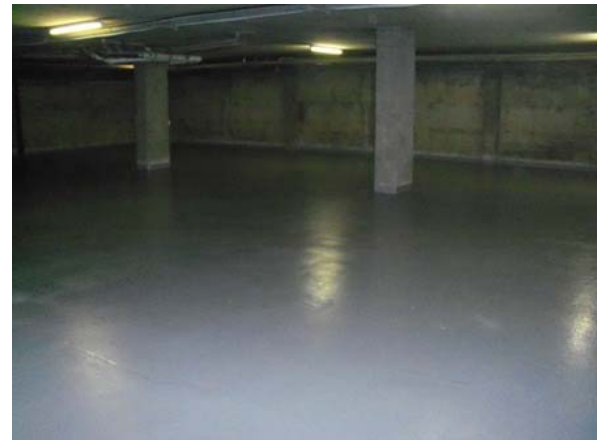
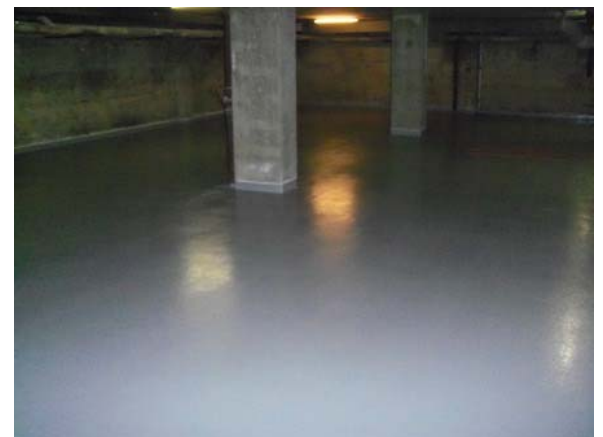
The Cleveland Terrace parking garage was compromised due to serious structural issues on two levels of parking decks. Heavy concrete deterioration, combined with unforeseen conduit led to water infiltration and slab deterioration. The garage needed a heavy-duty traffic-bearing membrane. Voided area on slab on grade (SOG) was also a major structural issue.

CSI was contracted to provide successful concrete repairs and the application of a heavy duty traffic bearing membrane. Working closely with the project owner and engineer, CSI provided cost-effective and innovative solutions, conducting bi-weekly progress meetings to ensure all parties were pleased with the work.

- Controlled dust, since the garage had no ventilation.
- Maintained optimal accommodation for residents, since the condominiums are located directly above the parking garage.
- Developed a system to gravity-feed multiple cubic yards of grout to the SOG voided area, to stabilize the slab without compromising it with too much pressure. Using a funnel system and vibration techniques, the CSI team correctly dispersed grout to the proper locations.
- Met a tight schedules. CSI worked with the project owner and engineer to develop and adhere to a strict schedule, ensuring that tenants could soon regain the use of their parking spots.
