PROJECT PROFILE

Office Building Park - Doral, FL

Building Facade Masonry Repair & Restoration

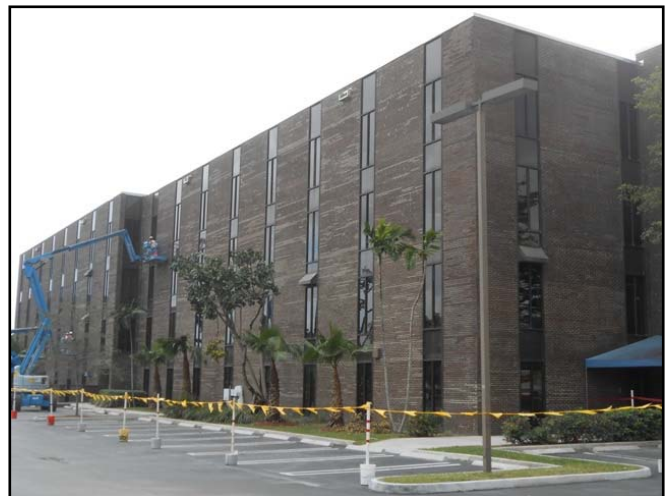
Over time, building tenants were exposed to an increasing water infiltration problem through the exterior façade. This problem was primarily caused by the presence of voids and cracks in the brick veneer mortar joints.

Factors such as the building's age, weather exposure, and lack of expansion joints all contributed to the deterioration of the building's seal.

- Pointing damaged mortar joints
- Routing out and sealing cracked bricks
- Pinning unstable brick
- Sealing entire masonry surface with a penetrating water repellent

The **CSI** team completed all repairs, and successfully restored the building envelope.
